DEVELOPMENT OF AN UNDERSTANDING OF THE FATIGUE PHENOMENA
OF BONDED AND BOLTED JOINTS
IN ADVANCED FILAMENTARY COMPOSITE MATERIALS

VOLUME III. FATIGUE ANALYSIS AND FATIGUE MODE STUDIES

A. C. Fehrle, J. R. Carroll, S. M. Freeman, et al.,
Lockheed-Georgia Company
Marietta, Georgia

TECHNICAL REPORT AFFDL-TR-72-64, VOLUME III

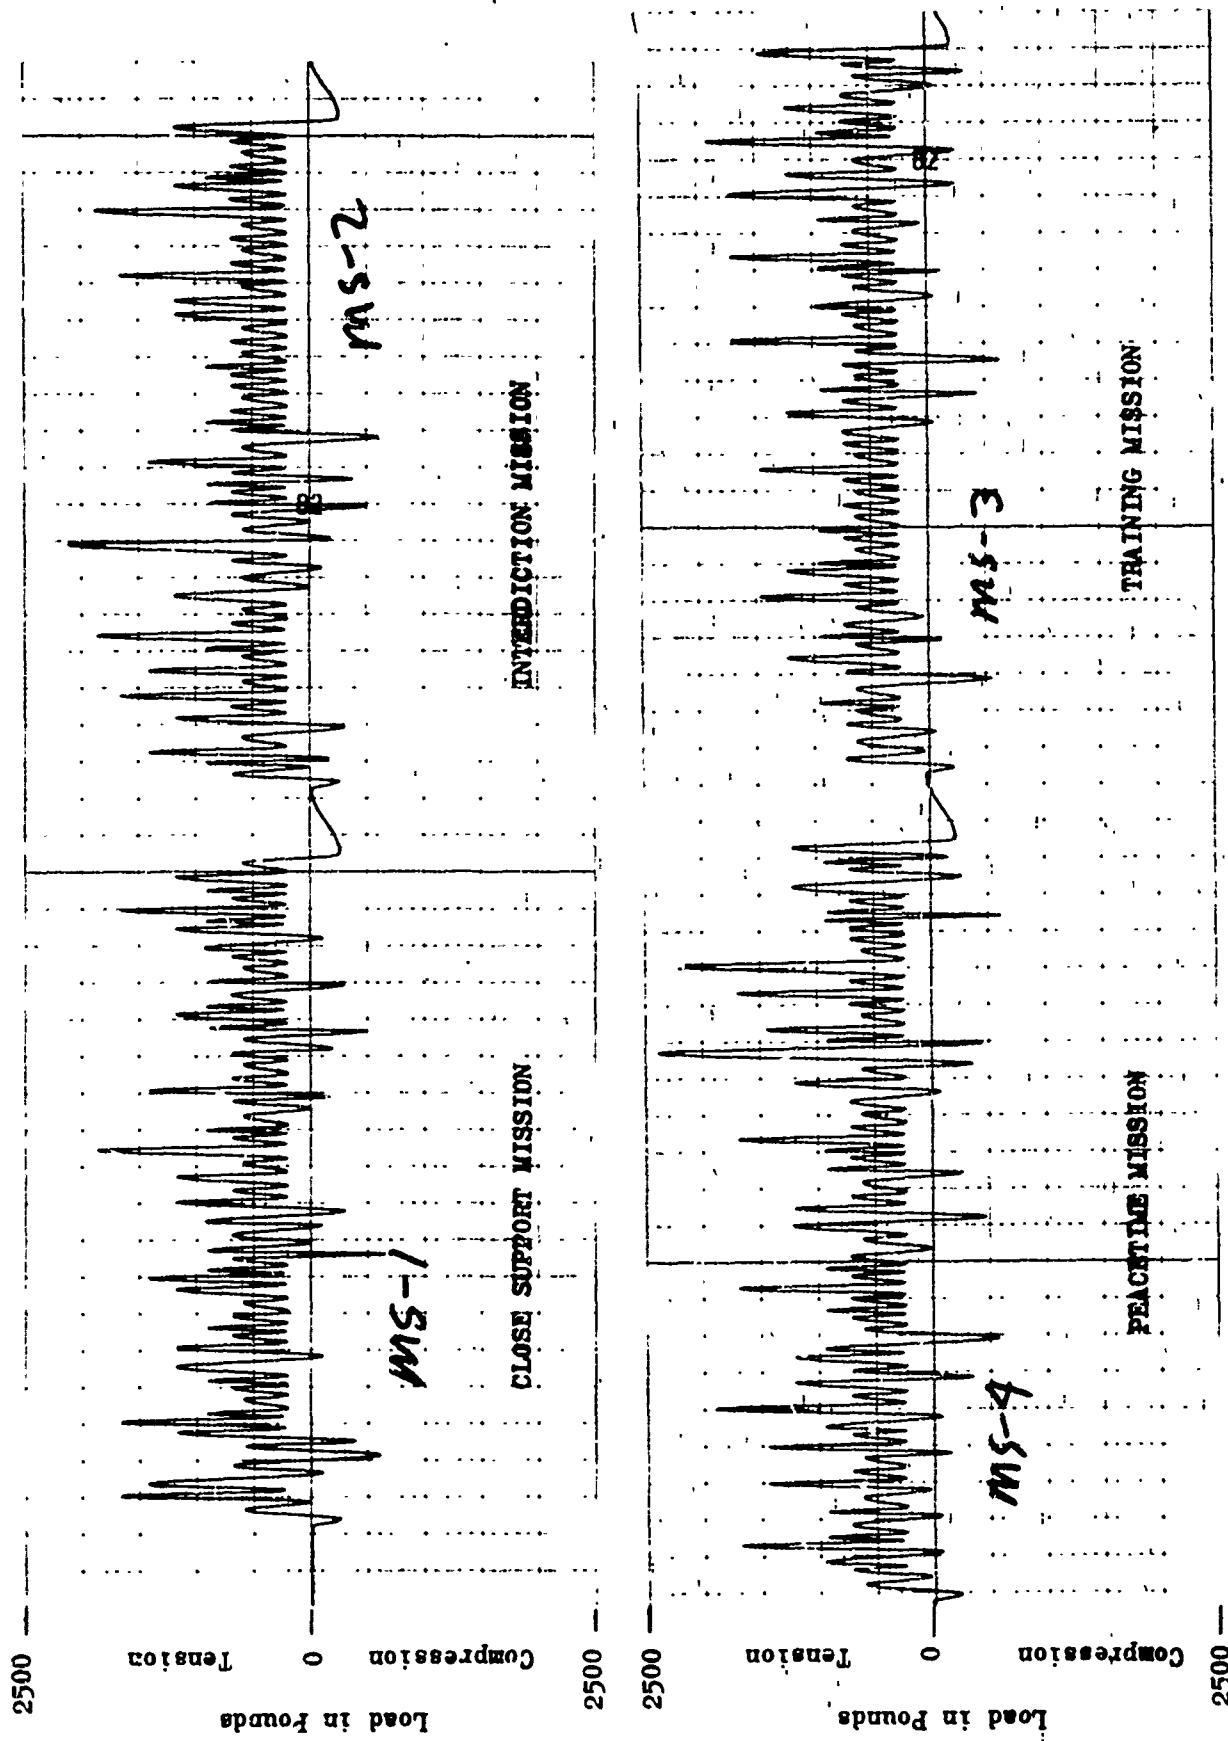
FIGURE 70. Typical Strip-Chart Recording of Individual Load Levels in Each Mission, Realistic Load Spectrum

The realistic loading test spectrum has been developed to represent a typical fighter aircraft wing maneuver loading spectrum and includes both frequency and amplitude variation. A detailed description of the realistic spectrum development is presented in 2.3. This spectrum is comprised of four basic missions or simulated flight loads repeated in random order, 4000 times. A typical loads trace showing all the load levels in each of the four different missions is shown in Figure 70.

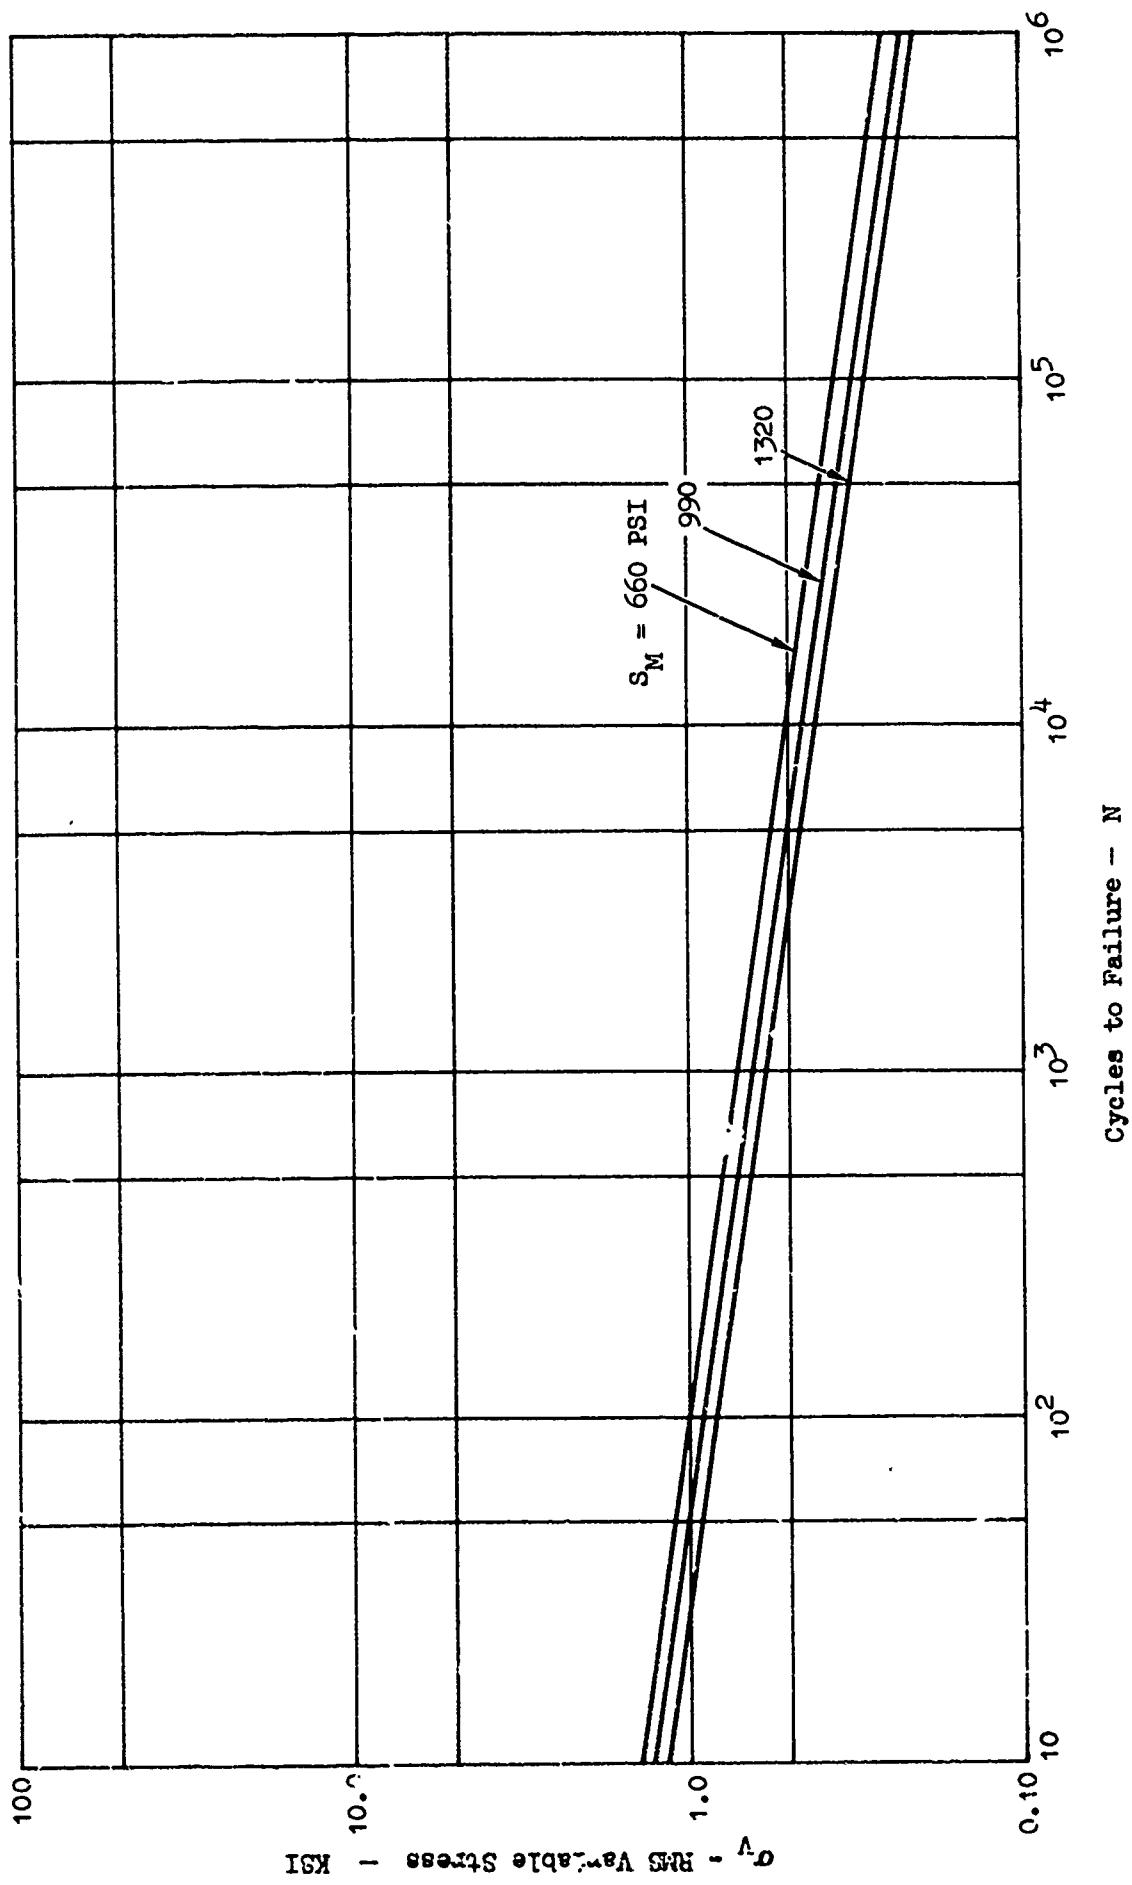
Figure 72 RMS Fatigue Curve Bonded Joints

There are no σ -N curves available for composite structures, specifically the joints evaluated here, so the constant amplitude fatigue curves developed for this program were "randomized" via the procedures of Reference 10. These σ -N curves for both bonded and mechanically fastened joints are shown in Figures 72 and 73 and have been used in the cumulative damage analyses here.

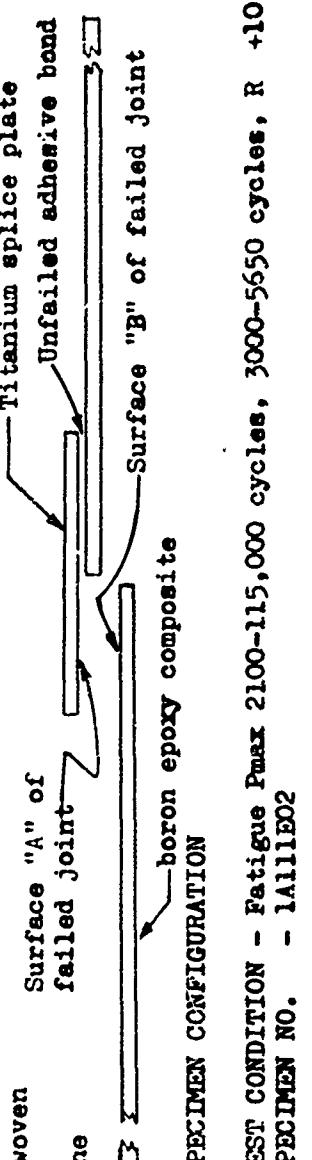
- 1) Arrows A indicate filament of woven adhesive carrier (scrim).
- 2) Arrows B indicate imprint of the glass scrim cloth used with the boron-epoxy tape.
- 3) Area enclosed by circle (o) is shown at 500X. Notice topographical features (cracks) of resin matrix that was adjacent to boron filaments.

Figure 8U Typical View of Fracture Surface "A" in Adhesive Bonded Joint Specimen

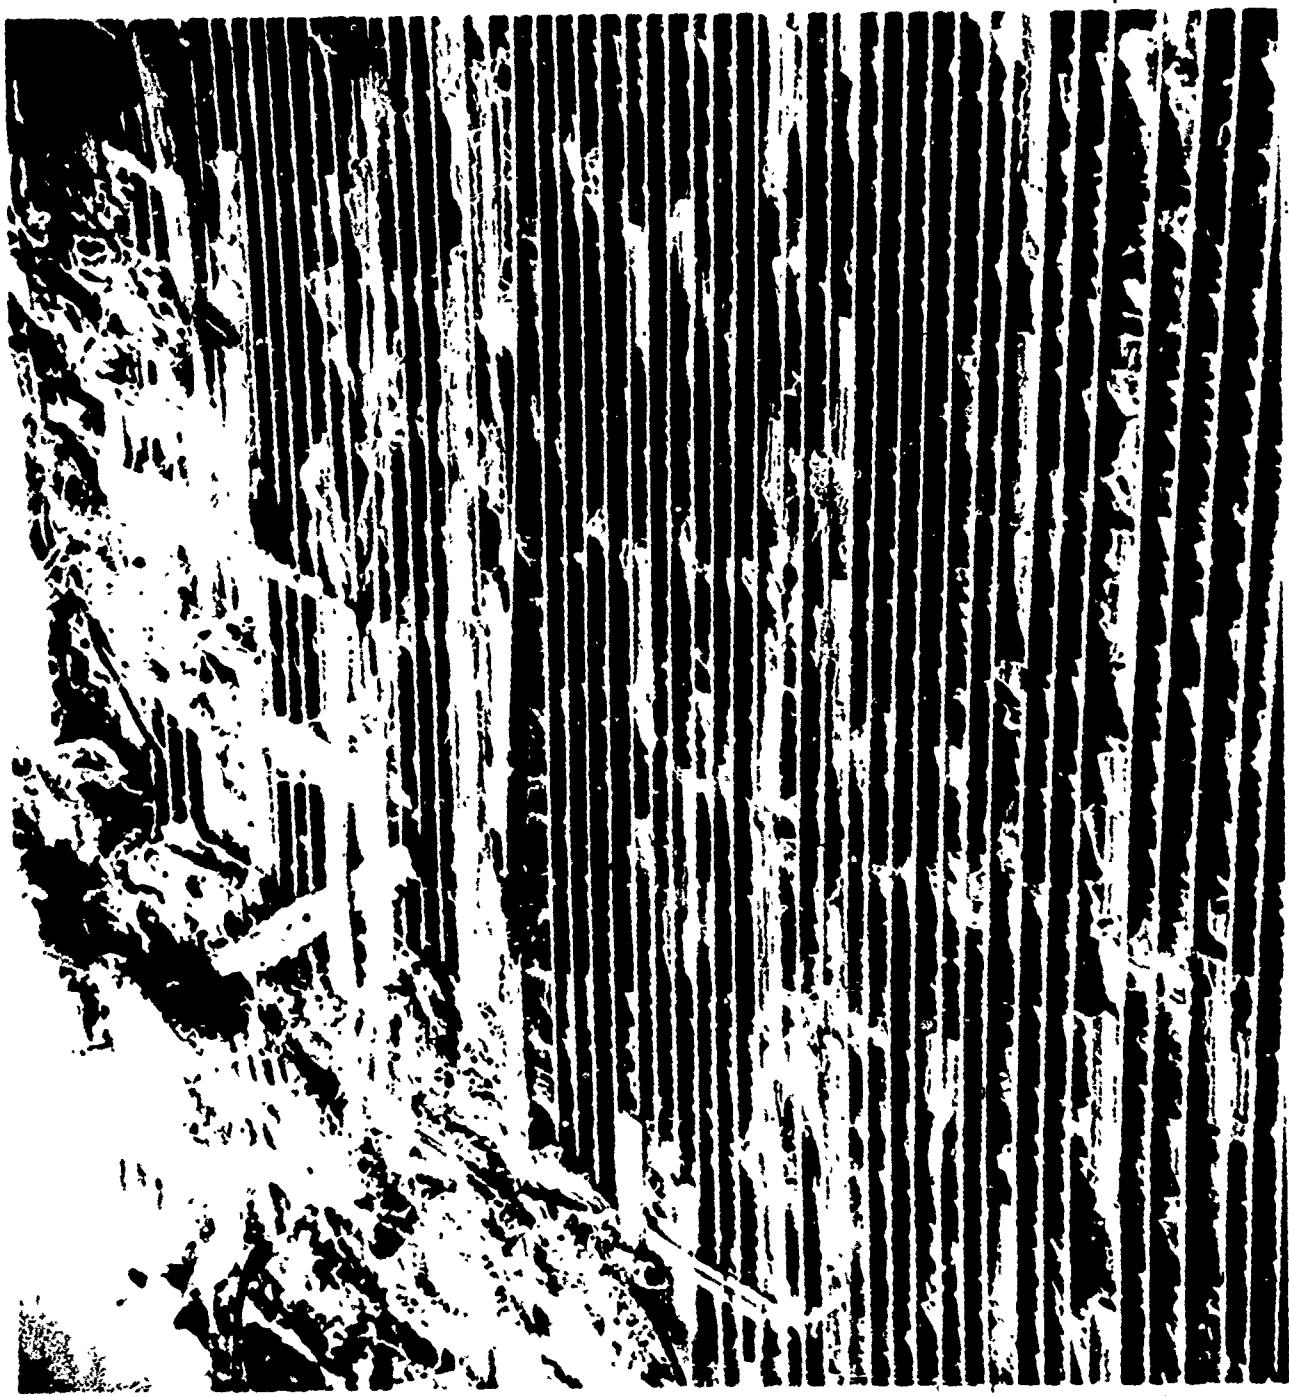
Figure 89 IA111D09 Failure Surface "B" -
Boron Adherend - Mag. 6X

The fracture surface of Figure 89 is a mirror image of the splice plate surface shown in Figure 88. The small square area outlined in this figure is the area selected for investigation by SEM photomicrographs. Figure 90 is the larger area outlined in Figure 89 and was used as a map for more extensive investigation. Three different failure modes were studied with this specimen. One failure mode, Figure 91, was associated with shear at the adhesive surface; the second, Figure 92, was associated with shear within the adhesive along the adhesive scrim carrier (cohesive mode); and the third, Figure 93, illustrated once again the resin/fiber interface shear mode associated with compression loading.

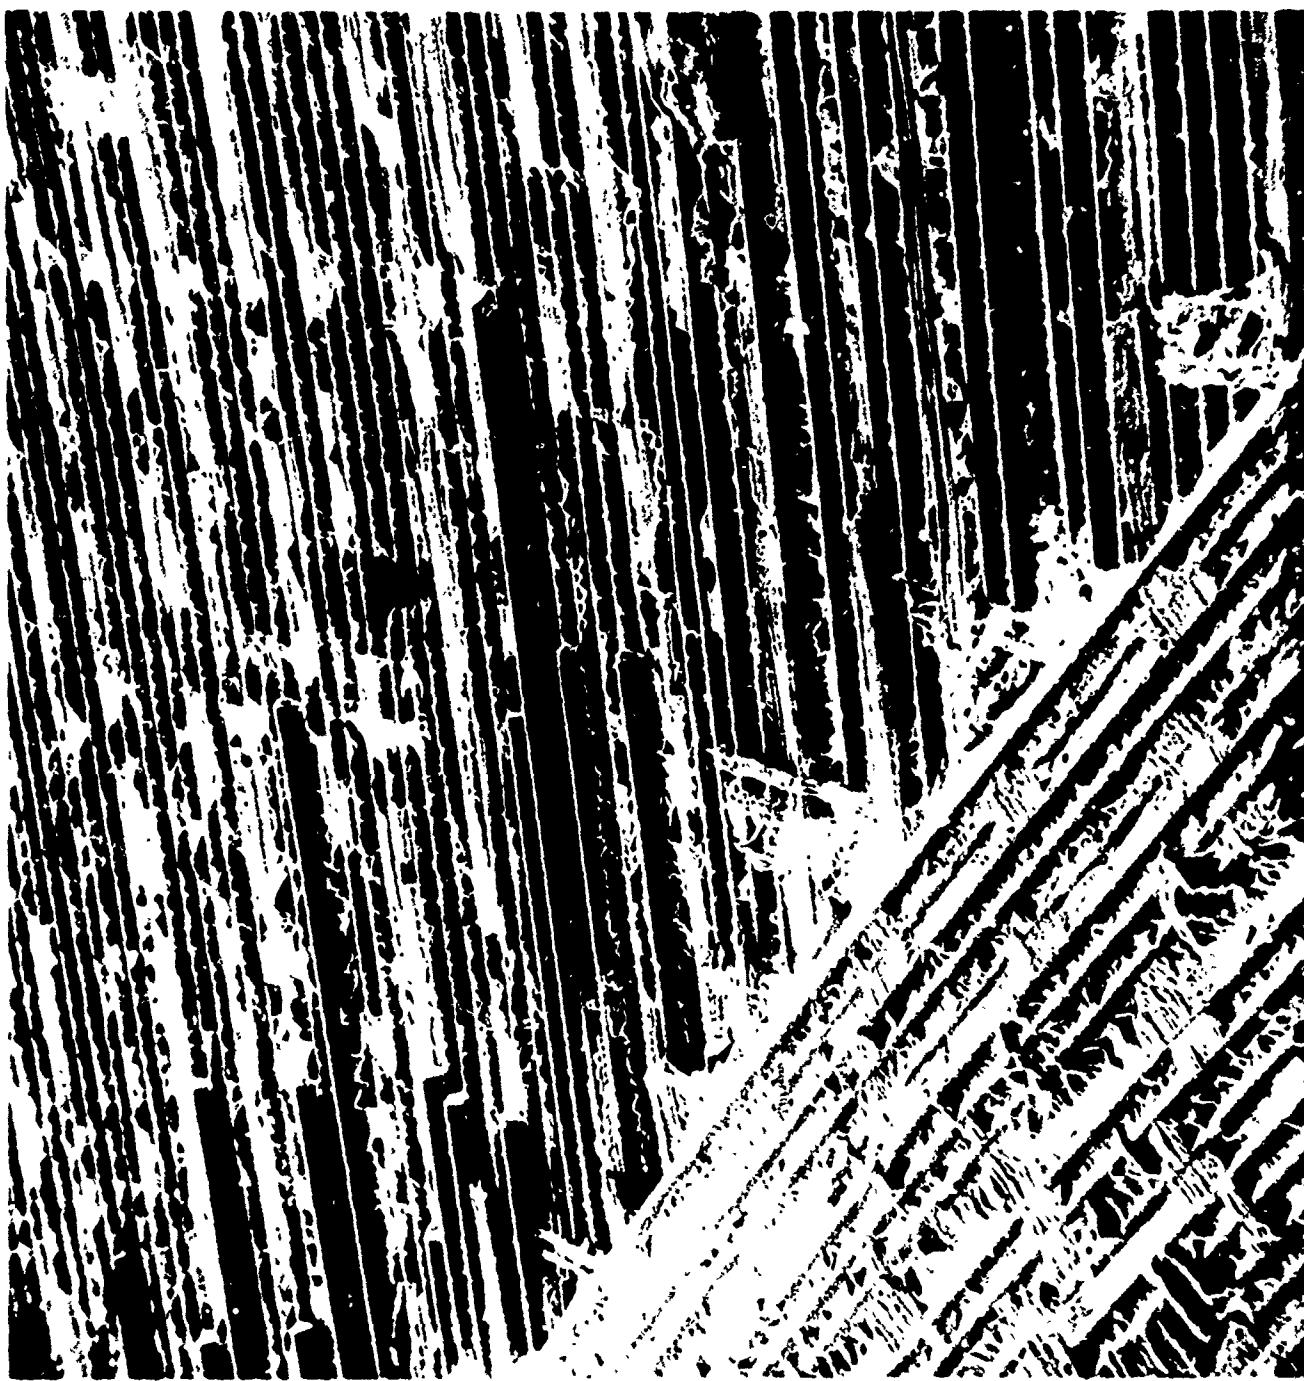
The square area outlined in Figure 95 is shown in Figure 99. The two different failure modes illustrated in Figures 96 through 98 are also visible in Figure 99. Figure 100 illustrates the same failure mode as Figure 97 and Figure 101 illustrates the same failure mode as Figure 98 since these represent the mirror images of those figures.

Figure 99 IA113A01 Failure Surface "B" Map
40X Magnification
(Reference Figure 95)

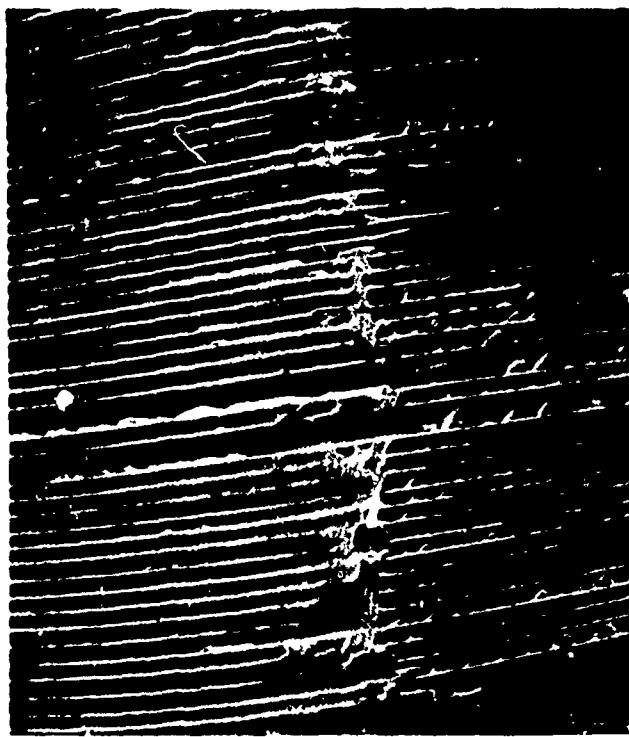
Figure 120 Specimen IC111A01 - Magnification 4X - Surface "B"

Figure 119 shows the general failure modes of this specimen which consist of a laminate-to-tee disbond, and fracture of the laminate. Failure Surface B, Figure 120, magnification 4X, indicates that the bond failed primarily in shear at the glass carrier scrim/resin interface in the surface ply of boron culminating in a static peel mode. It is apparent that the effects of side loading and laminate bending have caused plies near the surface to fail, thus propagating into total laminate failure.

A SEM specimen was removed from the area indicated on the specimen fracture surface in Figure 120. Figure 121, a 20X SEM photomicrograph of a section of this area, shows the change in surface topography where the fracture mode shifted from shear to peel. A higher magnification (100X) SEM photomicrograph of the fracture transition zone is shown in Figure 122.

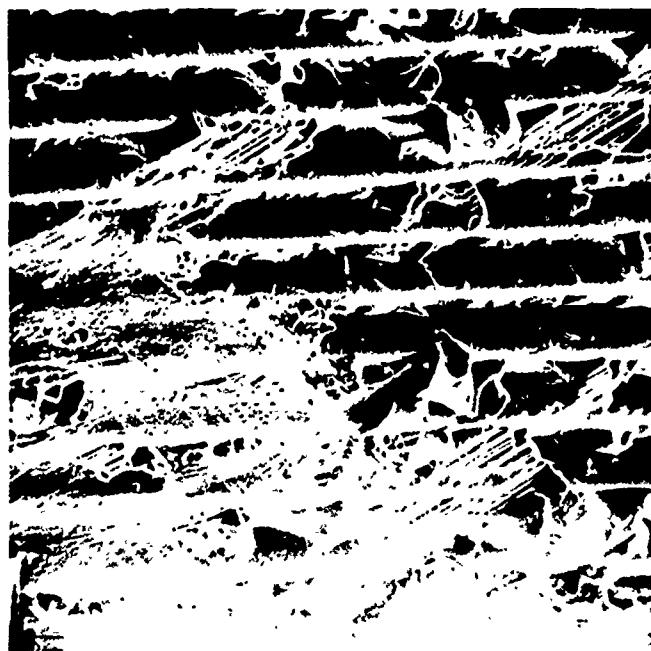
Figure 133 Spalling of Boron Fibers in 45° Plies
Subjected to a Tension-Tension Fatigue
Load Applied at 0°

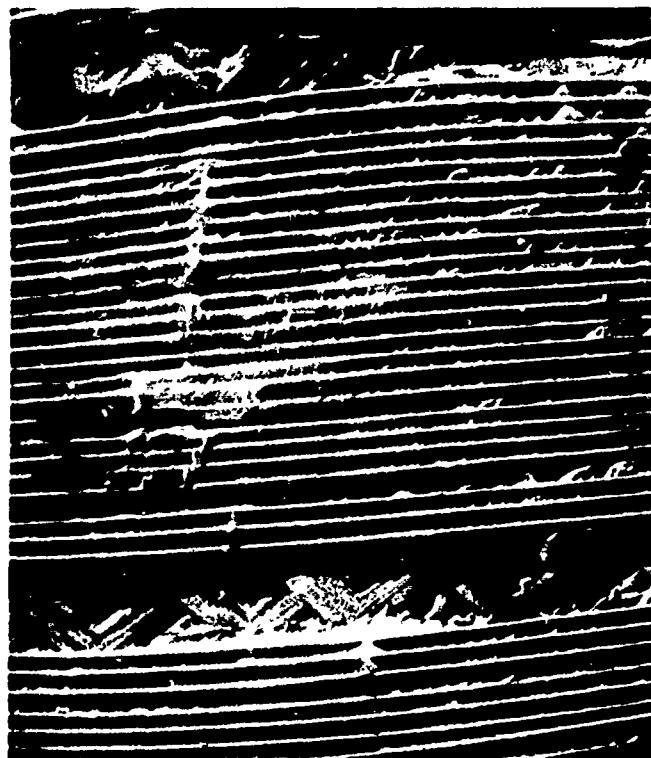
Figure 134 Peel Failure in Matrix Subjected to Static Tension
